Subject: Eaton Corporation
Bowling Green, Warren County, Kentucky
Environmental Priorities Initiative/Modified Preliminary Assessment
EPA ID No. KYD098950306
TDD No. F4-8910-22

ENVIRONMENTAL PRIORITIES INITIATIVE
PRELIMINARY ASSESSMENT OF
EATON CORPORATION
FITZGERALD INDUSTRIAL DRIVE
BOWLING GREEN, KENTUCKY 42101
EPA ID #KYD098950306

MARCH 13, 1990

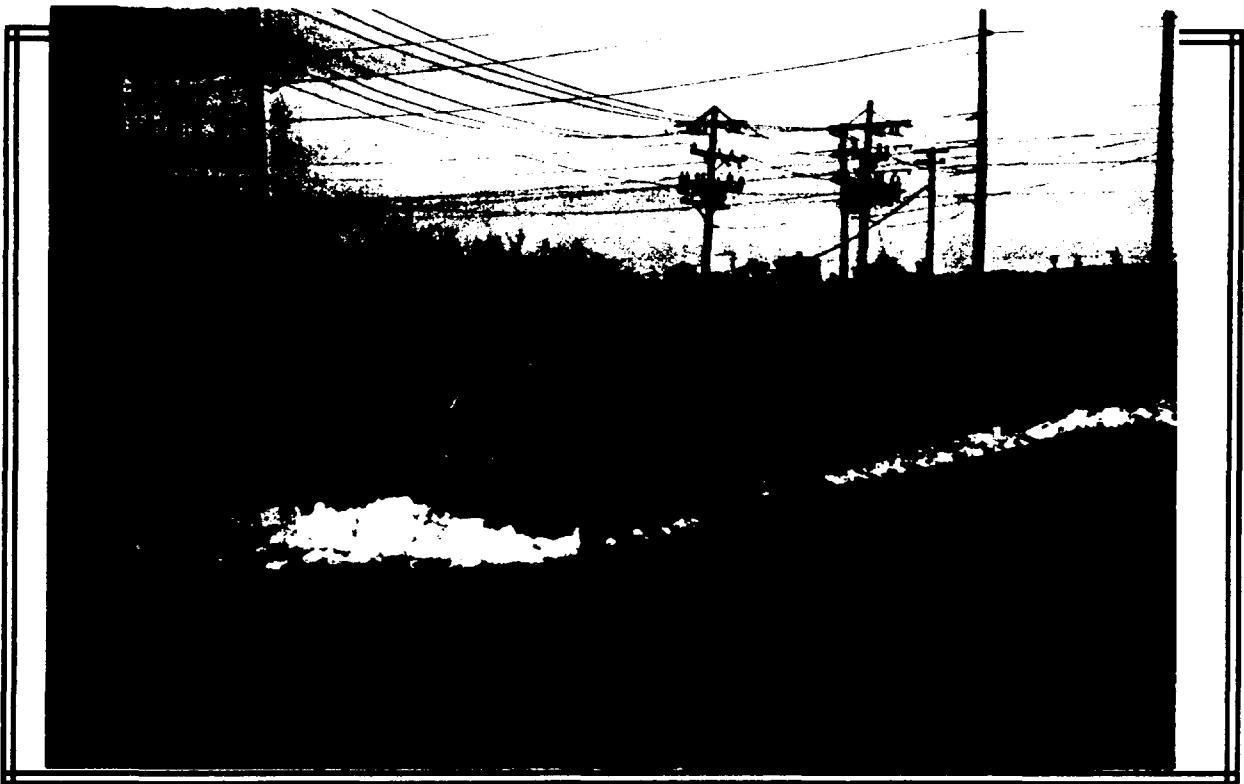
SWMU DESCRIPTION: A concrete-decked area is located in the northwest portion of the facility property and is used for the dumpster. This 20-cubic-yard dumpster is used to dispose of stainless steel scrap. Disposal and recycling of steel scrap waste is conducted by Klempner Brothers located in Louisville, Kentucky. Pickups of the dumpster are approximately once every 1 to 2 weeks (Refs. 1, p. 13; 22).

Photograph No. 9 (SWMU No. 9) Dumpster used to dispose of stainless steel scrap.

RECOMMENDATIONS: No Further Action. The dumpster appeared to be in satisfactory condition. No releases were seen during the inspection.

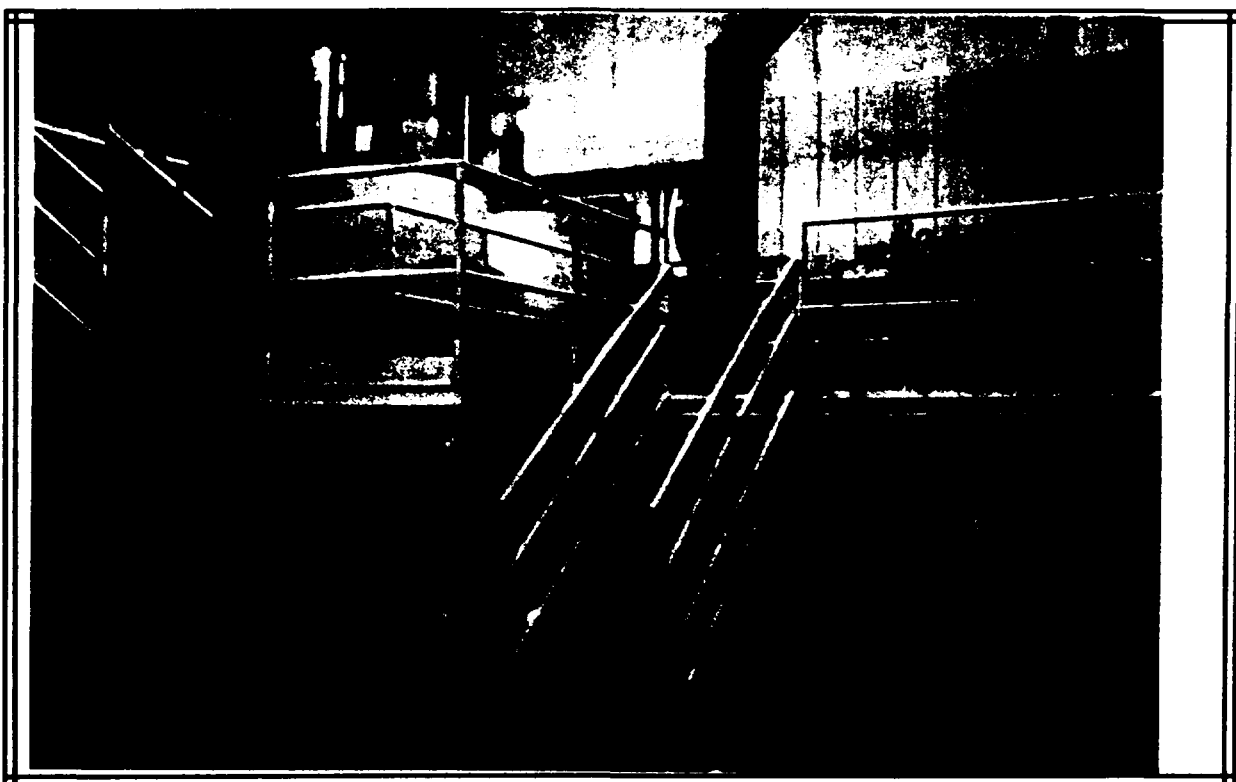
Photograph No. 16 (SWMU No. 16) View of the Phase II Wastewater Treatment Plant.

RECOMMENDATIONS: No Further Action. There was no evidence of releases from this unit during the VSI.
